HOME INSPECTION SERVICE, INC.

YOUR INSPECTION REPORT

E-MAIL ADDRESS:	INSPECTION LOCATION:	CITY, STATE, ZIP:
newhome@gmail.com .	000 New Home Road.	Duluth, GA 30000.

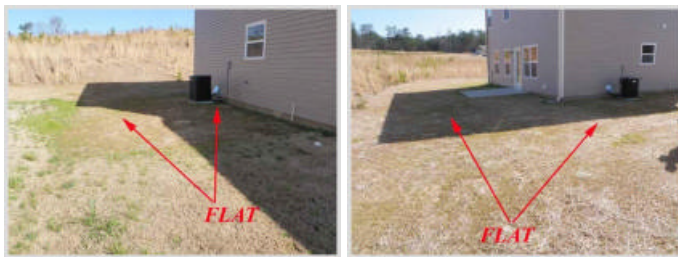
The grade is flat next to the foundation. Final grade should have a downward slope away from the home along all sides of the foundation walls / slabs. The final grade should provide a minimum slope of 6 inches within the first 10 feet. **Exception:** Where lot lines, walls, slopes or other physical barriers prohibit 6 inches of fall within 10 feet, the final grade should slope away from the foundation at a minimum slope of 5 percent and the water should be directed to drains or swales to ensure drainage away from the structure. Swales should be sloped a minimum of 2 percent when located within 10 feet of the building foundation. Impervious surfaces within 10 feet of the building foundation should be sloped a minimum of 2 percent away from the building (see CODE R401.3, 2006 Edition).

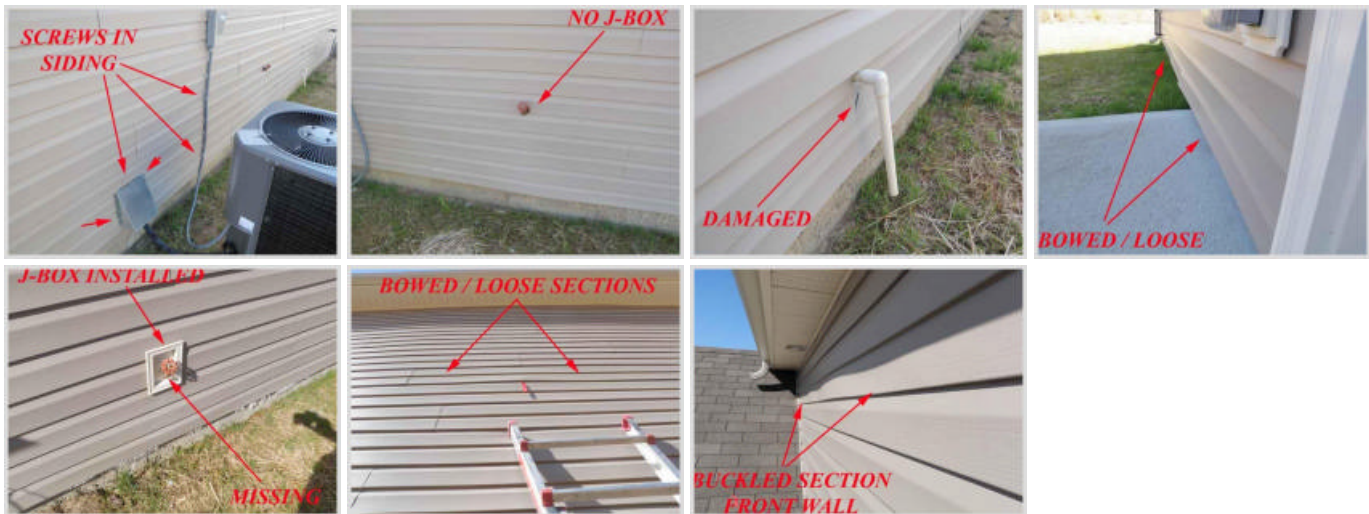
- (c). Loose, warping or buckled sections of siding noted, front wall (*upper section outside the upper bathroom*), right wall (*along the bottom and top, see red tape*), back wall (*right side, along the bottom*), left wall (*along the bottom, check all areas around the home*). To permit expansion and contraction, panels should hang freely from the nails. This allows panels to move as the temperature changes. The nails should be driven until there is 1/8 to 1/16" of space between the nail head and the nailing flange.

- (e). Hole noted in the siding, left wall (*area below the T.P.R valve discharge line*). All exterior walls should be covered with approved materials designed and installed to provide a barrier against the weather and insects to enable environmental control of the interior spaces (see CODE R703.1, 2006 Edition).

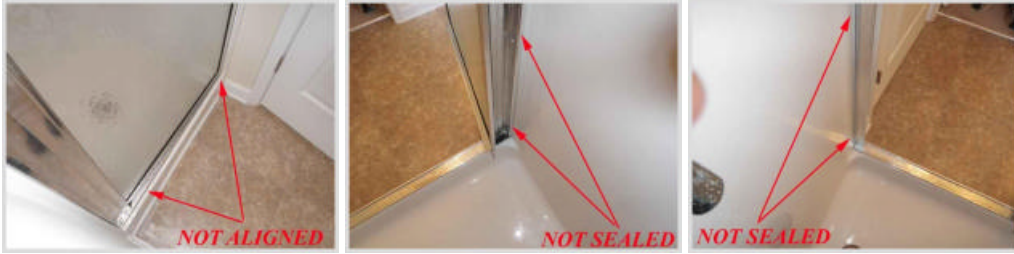
- (a). Area around the shower door frame is not sealed.
- (b). Adjustments needed to the shower door (*not properly aligned*), repair as needed.

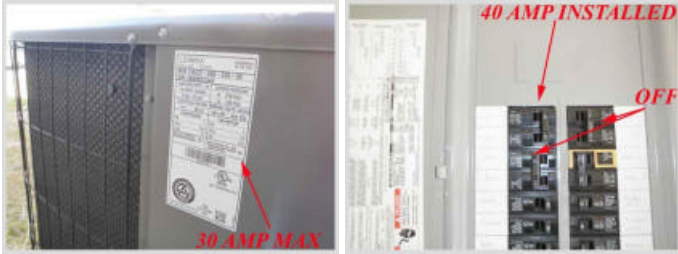
- (a). Some of the breakers were in the off position at the time of the inspection. Have reason verified by a licensed electrician
- (b). The breaker(s), is oversized for the Air Conditioning unit(s), 40 amp installed, should be 30 amp max. Heating and cooling equipment should be installed in accordance with the manufacturer's installation instructions (see Standard Mechanical Code 304.1).

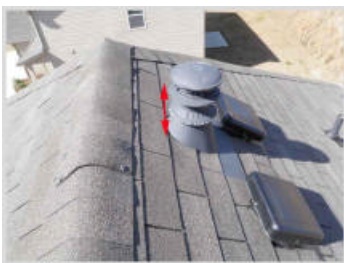
The exterior section of the vent terminates about 10 to 12 inches above the roof. Depending on the **pitch** of the roof the vent should terminate between 1 foot to 8 feet (see Standard Gas Code, 503.6.6, or Figure 503.6.4, 2006 Edition). Have the vent checked to make sure it is adequately installed above the roof.

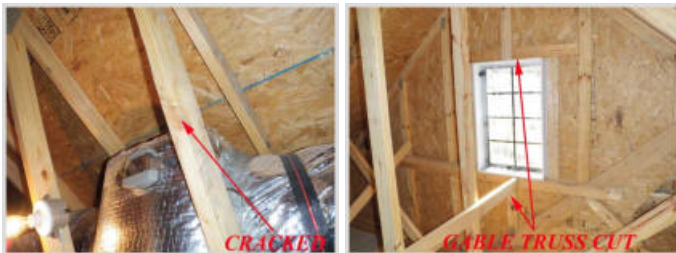
- (a). The gable truss above the garage was cut to allow the window to be installed.
- (b). Cracked truss member noted in the main attic (*left side of the furnace, see red tape*). Trusses should not be damaged / cut or altered in any way, without the approval of a registered design professional (see CODE R802.10.4). I recommend further evaluation of the entire truss system by a truss engineer (***be sure to get a copy of the sealed Engineers report / recommendations for your records. A sealed repair drawing is required for proper remediation***). After the repairs have been performed the Engineer will need to reevaluate the truss to insure that the repairs were performed correctly.
